PHI GAMMA DELTA

Gamma Tau Chapter

Assessment Report

BUILDING ASSESSMENT – Executive Summary

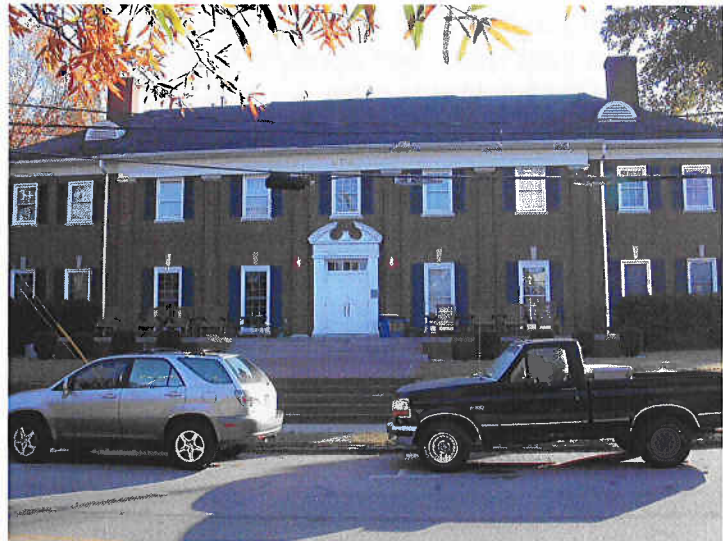
Front Yard: The exterior of the building is comprised of primarily flat lawn area in the front, or west side, supported by a short, brick retaining wall which runs north and south along the pedestrian sidewalk next to Fowler Street. Wide brick stairs and a brick walkway, extend to the brick porch at the entrance to the building. The uncovered front porch is approximately 15' deep and 60' wide, centered on the front building facade. The front retaining wall, which is at the location of the Fowler Street property line, is approximately 40' from the front edge of the building, which lines up with the Sigma Phi Epsilon Fraternity to the north and the Zeta House to the south. The retaining wall turns back at the south end of the property, becoming the north face of the parking and building service area. A wooden fence has been erected from the retaining wall to the south side of the building to hide the south side service area. This parking area for approximately nine cars is accessed by an east-west alley, which connects Fowler to Techwood Drive to the east

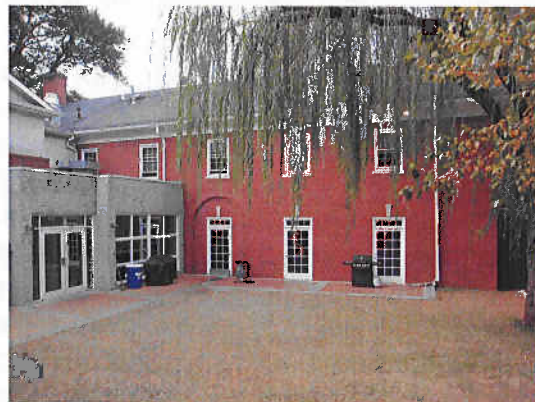
Rear Yard: The rear or east yard, which is used as a gathering and party space is at approximately the same elevation as the interior of the house as indicated by the civil drawing that was produced when the addition was added in 1994/95. Over time, use of the back yard area for Island Party has filled the back yard with sand, without removal after the party. This has resulted in an elevated back yard to the current level, burying the concrete steps from the uncovered concrete and brick back porch. This appears to have caused some drainage issues during heavy rains.
